# La restauración del papel pintado en la 'Mythologischer Saal'

Concept and restoration. The wallpaper in the 'Mythologischer Saal'

NEUES MUSEUM. BERLIN

Texto y fotos: **Thomas Lucker**, escultor y restaurador ◀

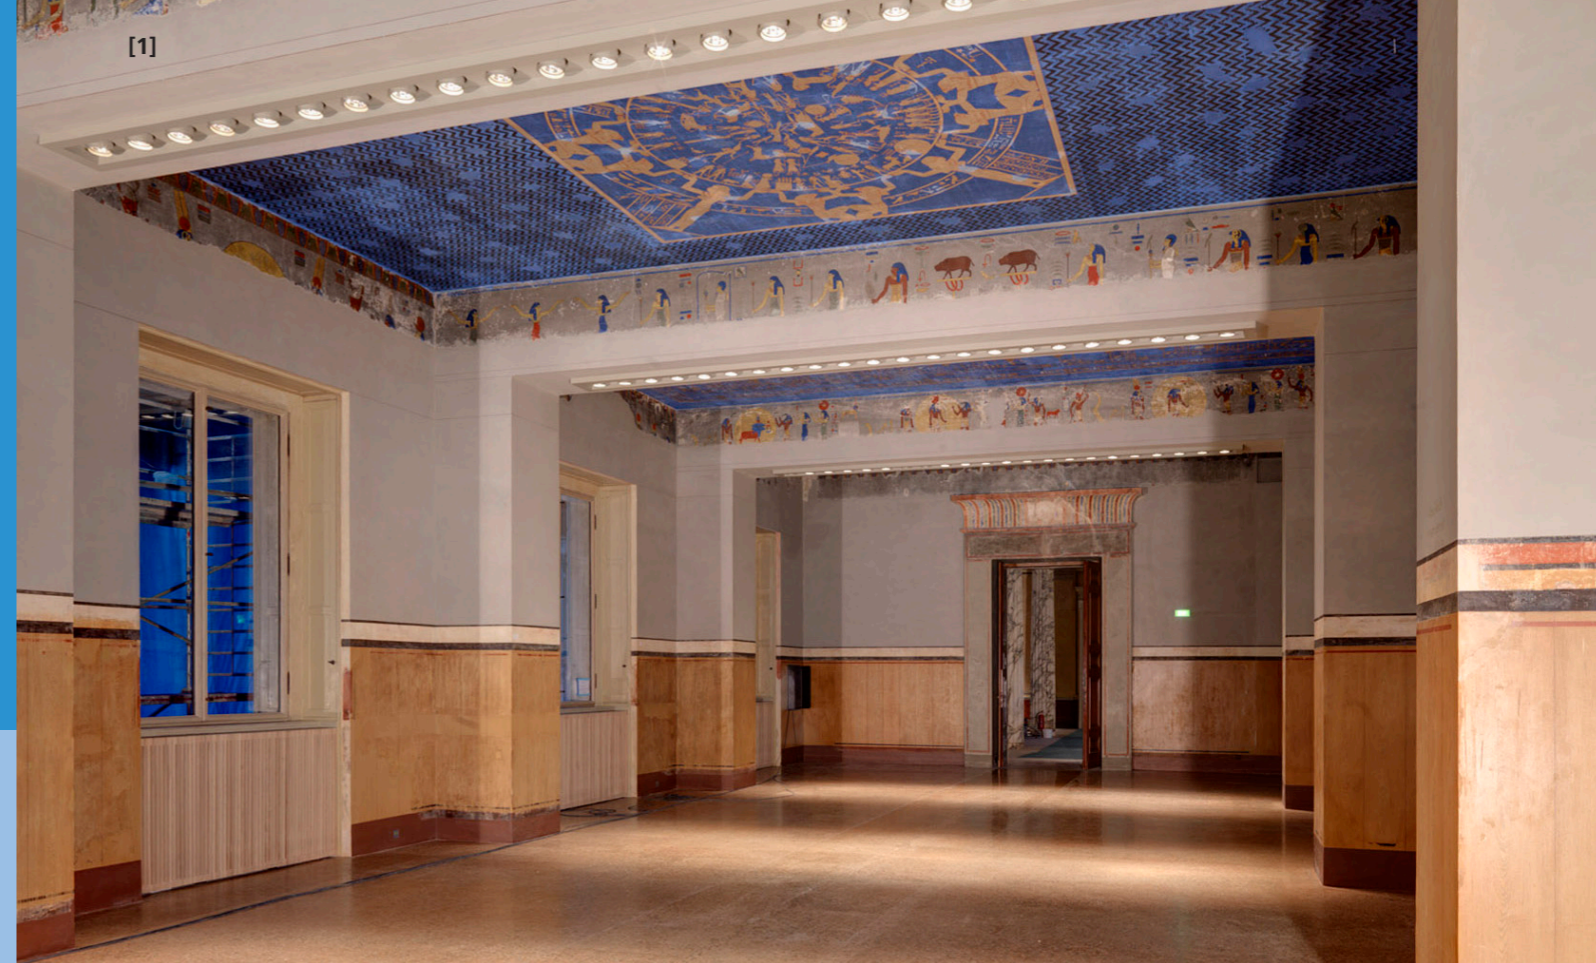
[1] Mythologischer Saal después de la restauración, en 2009. Vista hacia el Noroeste.

[1] Mythologischer Saal after restoration was completed, 2009. View toward north-west.
