► La restauración de las fachadas de la galería dorada

Palacio Ducal de Gandia

GANDIA.VALENCIA

The restoration of the golden gallery façades ◀

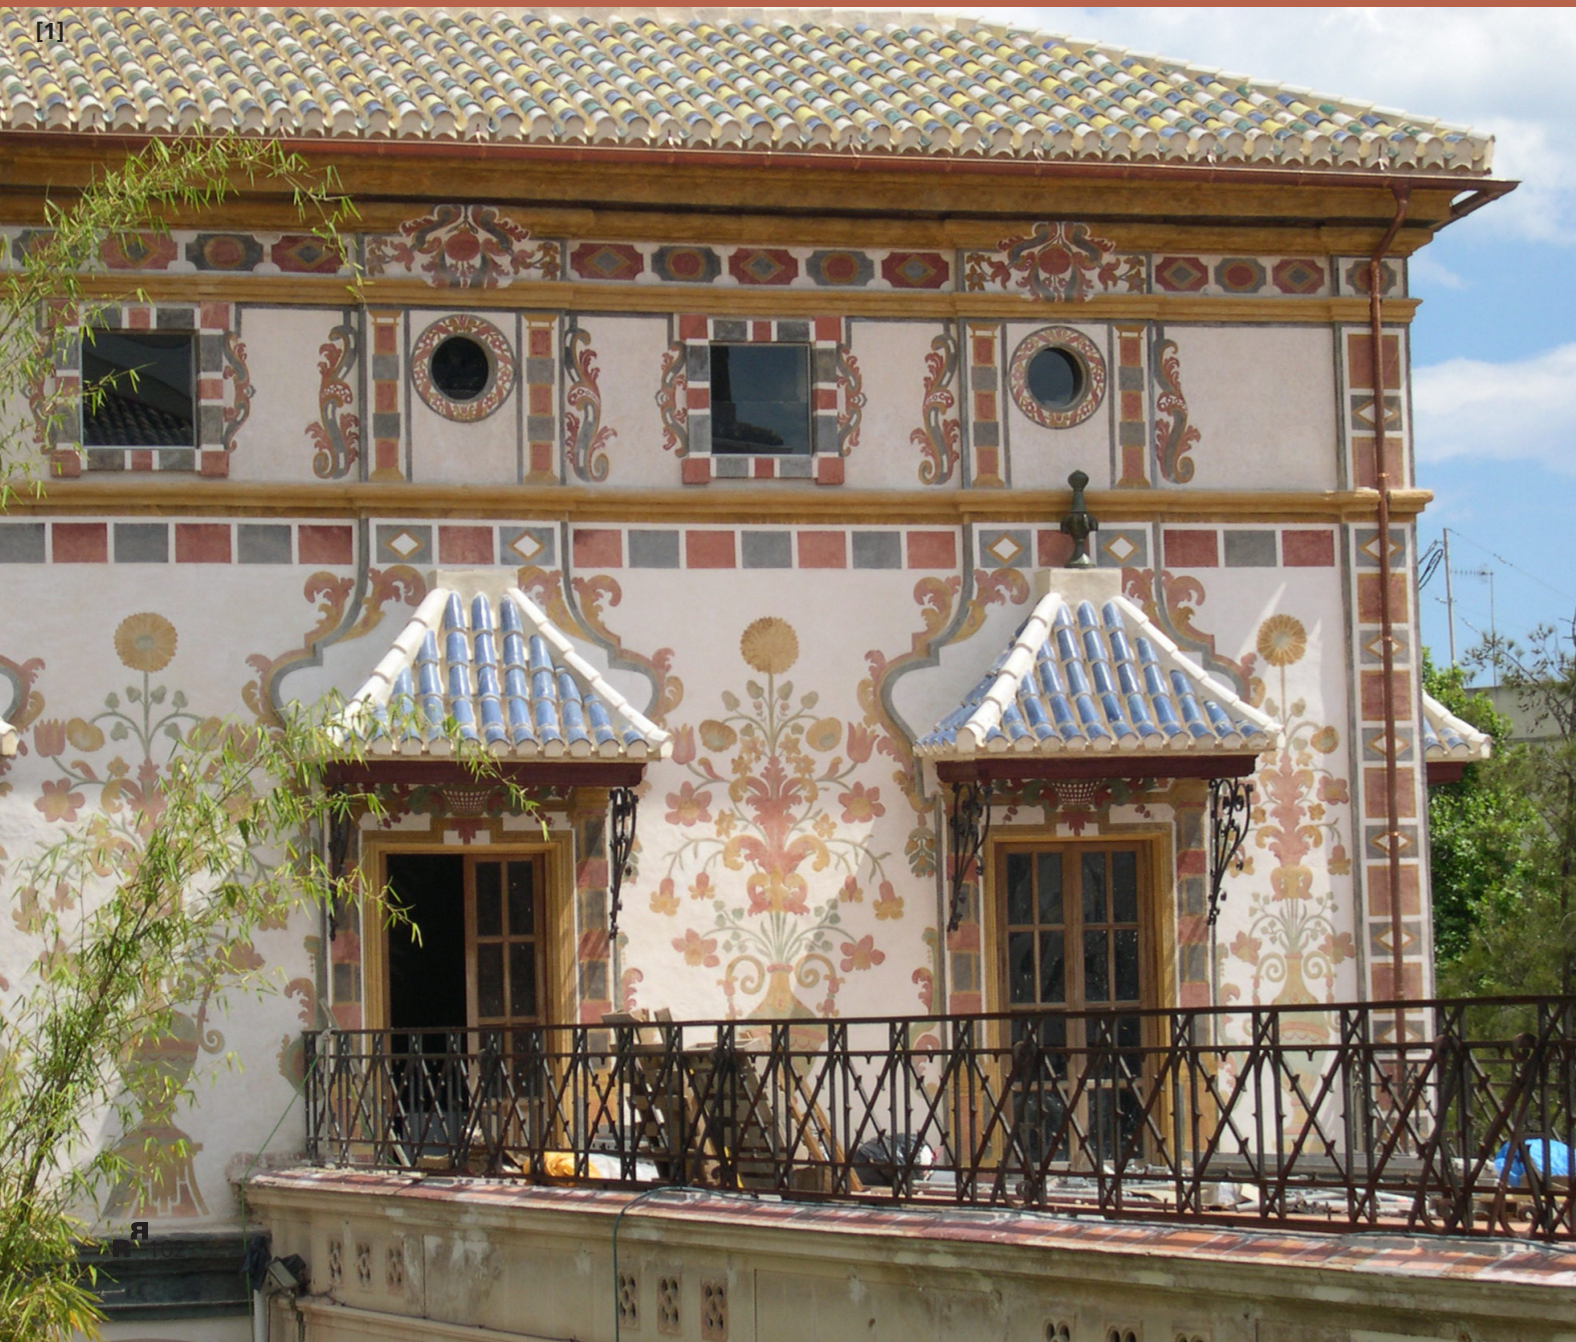
[1] Resultado de la reintegración pictórica de la fachada del “patio de las cañas”

[1] Result of the pictorial reintegration of the “patio de las cañas” façade.

Al inicio del proceso de intervención, las fachadas presentaban un aspecto muy diferenciado entre sí. Mientras que la del “Patio de las Cañas” mostraba las pérdidas, erosiones y depósitos superficiales propios de las condiciones climáticas, el paso del tiempo e intervenciones puntuales anteriores; las fachadas “Norte” y “Este” mostraban un repintado “total” tras una actuación relativamente reciente, que trataba de reproducir los motivos originales.

Con el fin de comprobar lo que se conservaba bajo el repinte, se realizaron una serie de pruebas de limpieza en las fachadas “Norte y Este”, mientras paralelamente se trabajaba en la del “Patio de las Cañas” con la consolidación estructural de los revoques pictóricos y la limpieza de

At the beginning of the intervention process, the faces themselves presented different aspects. While “The Patio de las Cañas” showed the losses, erosions, and superficial deposits of the climatic conditions, the passing of time and specific previous interventions, the “North” and “East” façade showed a “total” repaint following a relatively recent action, which tried to reproduce the original motifs.

With the purpose of checking what was conserved under the repainting a series of cleaning tests in the “North” and “East” façades were carried out, while at the same time working on the “Patio de las Cañas” with the structural consolidation of the plastering and the cleaning of the sediments and saline crust. Finally, given the im-
